U.S. Department
of Transportation
Federal Aviation
Administration

ADVISORY CIRCULAR 43-16A

AVIATION MAINTENANCE ALERTS

ALERT
NUMBER
273

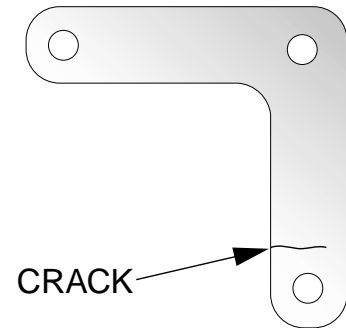
Piper; PA 18-150; Super Cub; Defective Wing Flap Bellcranks; ATA 2750

With the aircraft covering removed for replacement, the technician found both wing flap bellcranks cracked.

The submitter stated the only way to properly inspect the flap bellcranks (P/N's 40092-09 and -10) is with a flashlight and mirror or removal of the fabric covering. Both of the bellcranks were cracked in the same location and were in danger of complete failure. (Refer to the illustration.) The submitter recommended inspecting all like aircraft for similar defects as soon as possible.

Part total time-more than 8,000 hours.

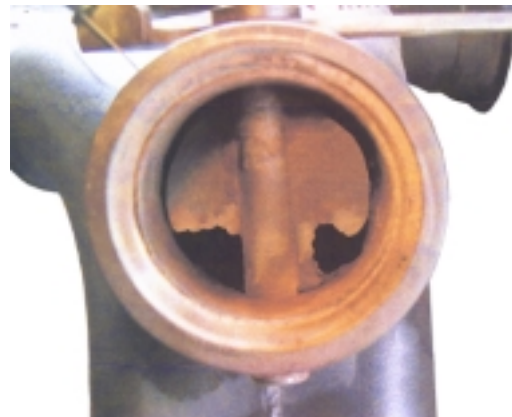
A technician inspected the engine and systems and discovered the turbocharger waste gate butterfly valve was missing approximately 40 percent of the valve plate surface. (Refer to the illustration.) Since the turbocharger turbine was not damaged, he suspected the waste gate valve plate eroded slowly from exposure to exhaust gas and heat.

The engine had accumulated approximately 730 hours of operation since a factory overhaul. However, there was no indication or record the turbocharger was changed or repaired since it was installed. The submitter recommended frequent and periodic inspections of the turbocharger unit at least annually.

Part total time unknown.

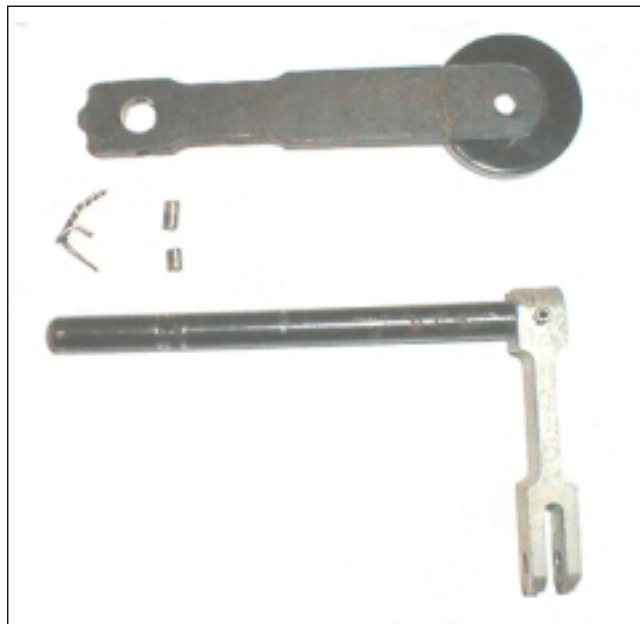
A technician found a roll pin, in the landing gear control handle linkage, was broken. The roll pin was safety wired in position; however, the safety wire did not last very long after the pin failed. With the roll pin broken, the shaft turned inside the hole of the gear handle, which was severely worn. (Refer to the illustration.)

Several factors could have caused this failure either alone or in combination. The aircraft was manufactured in 1975, and the roll pin and control handle linkage were probably original. It is possible, although unlikely, that the roll pin was defective. Also, in selecting either the “up” or “down” position with the control handle, pilots sometimes use an exceptional amount of “gusto” to move the control.

Violent movement of any aircraft control is not a good thing. Pilots, as well as maintenance personnel, should use only enough force to reposition the control. Usually, when it is necessary to reposition the landing gear, the cockpit workload is at its peak. Exuberant movement of the gear control handle may occur without realizing the force applied. So that bad habits are not developed, flight instructors are encouraged to teach “gentle but positive” movement of the gear control.

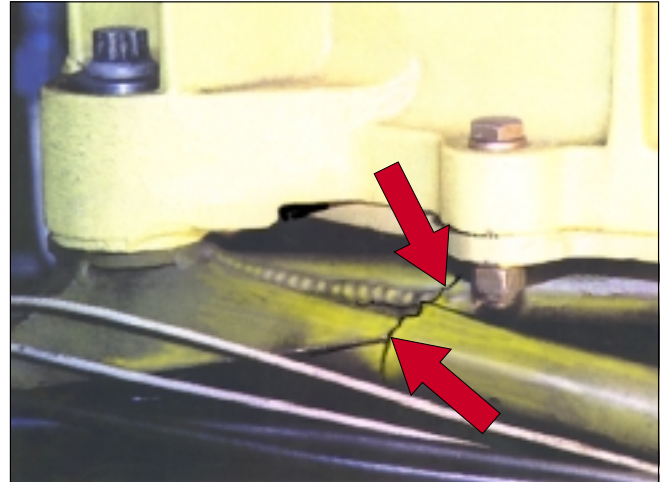
Enstrom; Model 280F; Shark; Structural Crack; ATA 5311

While conducting a scheduled inspection, the technician discovered a structural tube was cracked.

The 4130 steel tube was cracked between the left forward and left rear transmission mounts. The crack traveled across the tube, a weld, and into another tube. (Refer to the illustration.) The submitter believes this damage was caused by the accumulation of repetitive applications of stress leading to metal fatigue over the helicopter's 20 years of service.

The technician found another possible contributing factor while researching the maintenance records. An entry made several years ago documented a "hard landing" when the helicopter had approximately 1,000 hours of operation. Given the amount of vibration in this area, it seems unlikely the helicopter would operate 4,500 hours before this damage was found.

Part total time-5,503 hours.

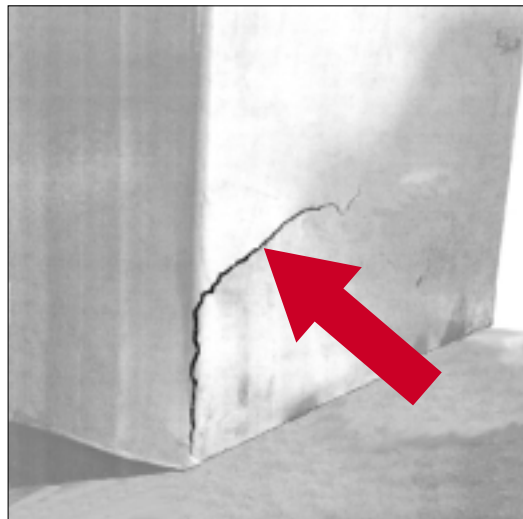
During a 100-hour inspection, the technician discovered a crack in the battery case.

The lead-acid battery was installed in the tail boom at Fuselage Station (FS) 119.48 in accordance with Supplemental Type Certificate (STC) number SH5117NM. The crack in the battery case was approximately 1 inch long, ran vertically, and was located in the left forward lower corner of the case. (Refer to the illustration.)

The lead-acid battery, which weighed 41 pounds, was a replacement for the nickle-cadmium battery, which weighed 38 pounds. The submitter believes the increased battery weight and location subjected the battery to more severe vibrations and contributed to the premature crack in the battery case. The conversion from a nickle-cadmium to lead-acid was authorized by STC number SR09185RC, and both STCs were authorized for installation on this helicopter by an FAA Field Approval.

The submitter found the same battery configuration on another helicopter, and the battery case was cracked in a similar manner.

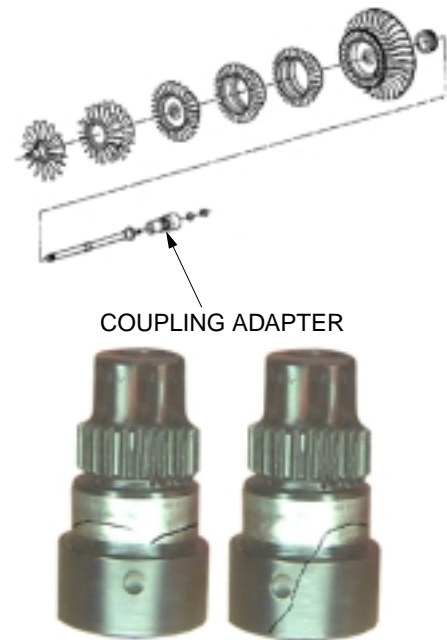
The Extex part is a Parts Manufacturing Authority (PMA) replacement part for the original adapter coupling (P/N 6871472 or 6898561). Extex issued Service Bulletin (SB) T-061, dated 03/02/2001, which lists the affected part serial numbers. The heat treatment of the adapter couplings affected by SB T-061 is suspected to be incorrect and may result in failure of these parts. Complete failure of this part was imminent.

Part total time-555 hours.

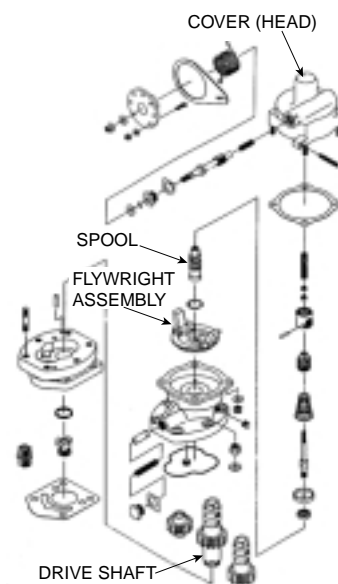
HARTZELL PROPELLER GOVERNOR FAILURE

After removing the propeller governor, the technician discovered the drive shaft was seized and the control lever was binding. He shipped the governor to an FAA-certified repair station for overhaul.

Repair station personnel disassembled the propeller governor and discovered that both the drive gear (P/N C-4191) and the spool (P/N B-3166) were broken. Also, there were several "impact" marks on the flyweight assembly (P/N B-4183-2) and the cover (P/N C-3174-1). (Refer to the illustrations.)

At the time of this report, the submitter had not determined a cause for these defects or details concerning the previous overhaul.

Approximate operating time since overhaul was 400 hours.
